# HF-Transceiver Kenwood TS-830

# Survival Guide

Kenwood TS-830 Survival Guide, ed. Olaf Rettkowski, DL9AI, ver.1.2, 03 Dec 2002

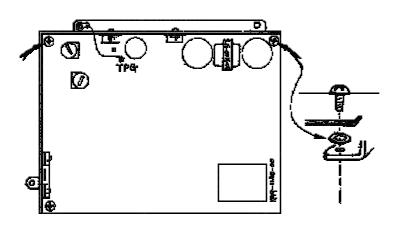
Some users may report an intermittent shift in the display and operating frequency. This may typically be a 1 to 4 KHz random shift. Cause will be a loose grounding screw on the AF/AVR unit heat sink.

3. Remove 5 screws holding the AF/AVR unit and swing the board over. Leads do not have to be unplugged.

- 4. Add two tooth-lock washer as shown.
- 5. Replace the circuit board and heat sink to the chassis, adding the solder lug as shown.
- 6. Solder a jumper between the TPG wrap post and the added solder lug.
- 7. Replace the top and bottom covers.
