AOR - AR7030 - AR7030 Plus - Communications Receiver

Dave N9EWO's Review

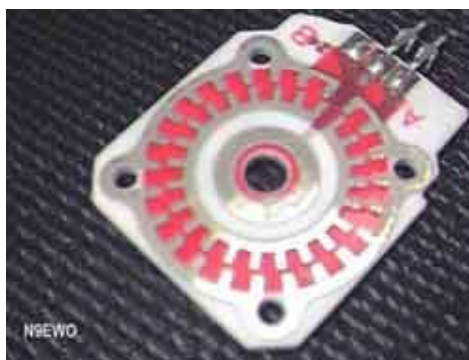
As I said, the failures are not all clear cut. Any sample of this encoder, when opened reveals a similar level of tarnishing to that which your picture shows, whether it is fully functional or faulty. This has led me to investigate the problem further.

The failures I have seen have a short of a few thousand Ohms between the centre pin and either of the outer ones. This short seems to be very close to the pins, rather than on the contact area of the substrate. This is checked when the substrate is removed from the encoder body as the one in your picture.

I tore a semi-defective "wheel" apart , it looks like tarnish might be one of the problems ? Have a look at the picture below, I have taken a pencil eraser and cleaned off 1/4 of the encoder's track to show the tarinsh. Also whatever Bourns used to lub this wheel with (if anything) sure does not last. I can feel a very dried out greasy "something" on it, but as you can see, no longer doing it's job. I don't think it's not all one problem. I still think half of the blame still goes to the "gray" poop that is on the track (see picture). **However**, now the real problem I think lies with the 3 little copper "wippers" that make contact with the track. You can actually just blow a bit on these and make them bend them (puts heavy damage on them too). They are very very thin and have no real spring to them (well not enough..that's for sure).

Production samples starting with serial # 102050, do NOT use this encoder (see other info below).
(Part marked as: Bourns Part No. ECW1J-B24-AC0024 Date Code: 9632X)
(N9EWO Photo)

Since my last email to you regarding the AR7030 on 19 January this year,we have addressed the Bourns click encoder issue using an Alps part. The PCB design for the new production control unit has been altered to accommodate the new controls as they are not a physical direct replacement for the Bourns part.

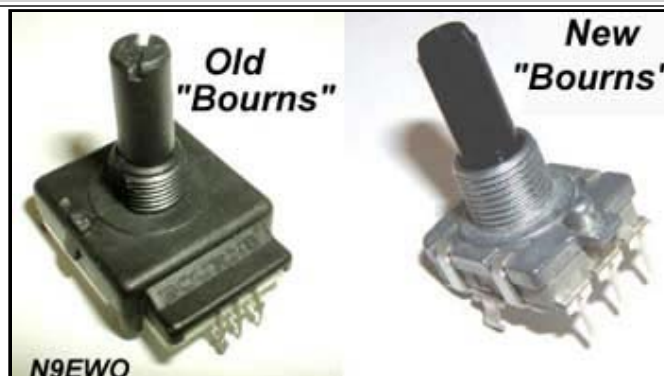
Issue even with the newer "Bourns" encoders ? (volume and "< >")

*New "Bourns" photo provided by Ismail KT6LN
Old "Bourns" photo and picture editing by N9EWO*

Above are pictures of the old Bourns "Volume" and "< >" encoder on the left and the latest Bourns part being used on the right. These encoders were used to the end of production.

These new "Bourns" encoders do rotate a bit tight when brand new (as installed in a AR7030) and I have found they will rotate easier with some use.

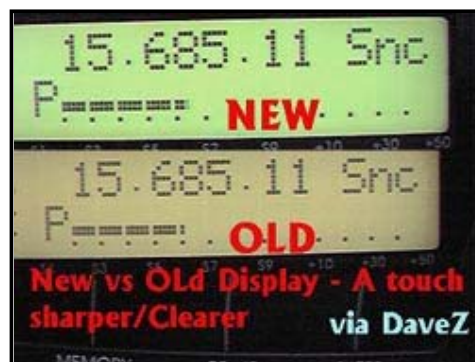
A picture below of the " New vs the Old Display" on # 5. This picture does not show a big difference,and it's not a real major change but a bit more than what the photo shows. But it does look a bit darker and shaper on the new version, provided you have the control adjusted right. The way you adjust the contrast on the new versions is a bit weird. The shapest and darkest is sort of in the middle and not where you think it would be in the area of the control. This does help being a bit sharper, but still does not offset it's small size and my eye's still can get tired of it all after a few hours staring at it.

NOTE: My # 5 "Plus" LCD display (top one) is with a 30 min "Warm-Up" time frame..then adjusted using the rear panel "contrast" control .

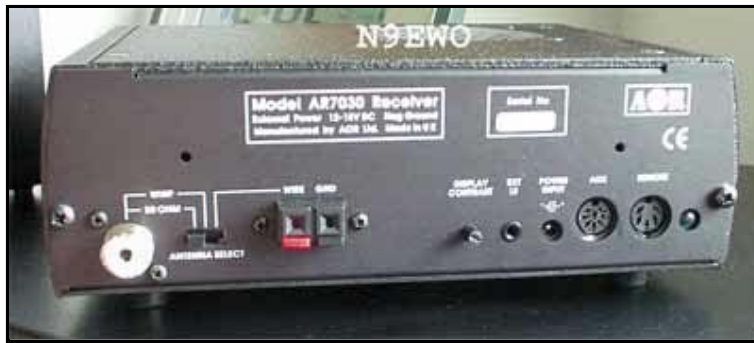
Rear view of the AR7030
(N9EWO Photo)

***** Do NOT use "Serial to USB" External Adapter Cables with the AR7030 *****
VERY IMPORTANT WARNING !!!!

It is HIGHLY recommended that ANY external "Serial to USB adapter cables" are NOT be used with the AR7030's serial computer connections at any time. Host computer should be equipped with "on the mother board" serial port or the use of a "properly installed" INTERNAL PCI or PCI express serial card. I have experienced nasty bugs first hand on this subject and just one little "burp" could easily corrupt the sets firmware that may not be fixable (well at least not without replacing the sets microprocessor). Sorry , but this rules out the use of most current laptops. So you have now been warned !!

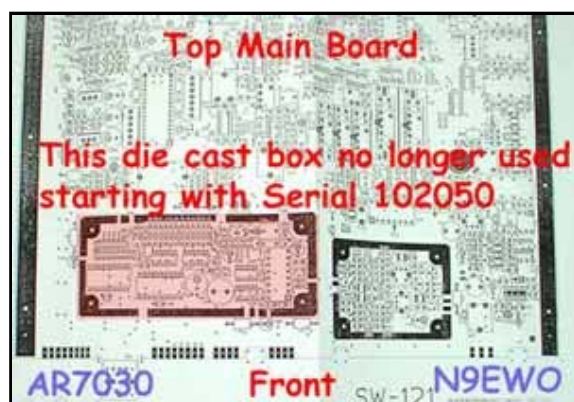
"As you have observed, the larger of the die cast boxes is indeed absent on the latest production run of the AR7030. The decision to omit the can was taken, as you quite rightly surmise, because of the stress it places on the PCB around Q47. We have always been aware that the level of radiation from the DDS system was low, however before deciding to omit the box extensive testing of the receiver was performed to check for the presence of any additional spurious radiation."

I had a peek in my "Above 102050 serial no" Plus 7030. Actually did NOT have to take it apart. I just shinned a little flashlight/penlight with a focused lens into one of the small 2 little holes on the rear cabinet and used the eye ball in the other..weird but it worked. Well as was indicated below (see below on this page for more info) my new sample is sure "missing" this "Die-Cast" shielded case (Left one). I cannot see this enhancing the operation of the set ?? I have noticed more background noise on this new set (with a few minor small hets mixed in places across the dial), but if this is because of the missing "Can", I could not tell you ?? So this is indeed correct information !! At least something does not sound right here...??

Missing Die-Cast Can missing in one of the later (Above 102050) AR7030's. Left one, facing the front of the cabinet.
(N9EWO Photo)
