Noise Blanker Modification for Alinco DX-70

Author: Jim KONK

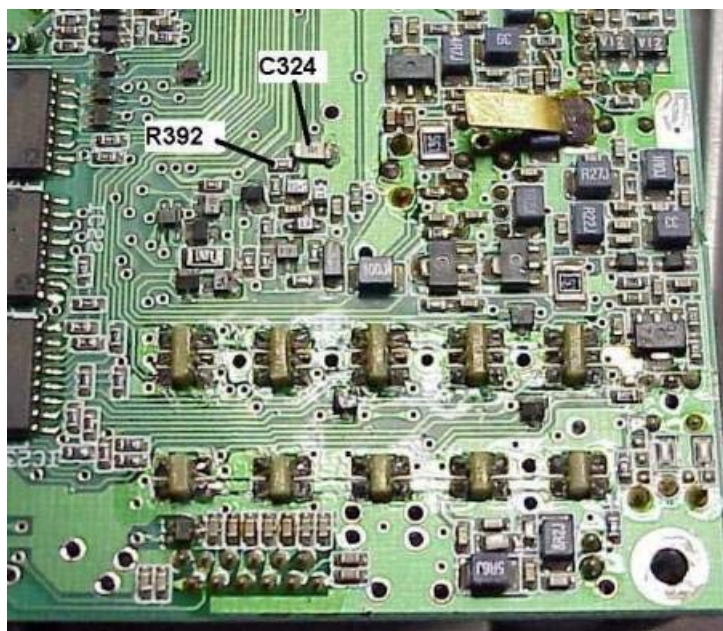
Perhaps the most common complaint among Alinco DX-70 users has to do with the poor performance of the noise blanker (NB). I have to agree--the NB performance is pathetic. Like other DX-70 users, I've found that the NB virtually destroys the desired signal, especially if the noise source is ignition noise from an engine operating at normal highway RPMs. Unfortunately, Alinco is unable to offer a remedy for the problem.

A noticeable improvement can be made to the noise blanker by changing the value of C324 on the Main Board to a smaller value. This mod allows the noise blanker to attack more quickly on noise pulses and it also reduces the duration of the blanking action. It is also necessary to verify the value of R392 to ensure the correct NB time constant exists. These components are located on the backside of the Main Board, which is the PC board located under the unit's top cover.

9. Remove the 6 screws holding the Main Board to the chassis and carefully lift the front edge of the Main Board up and lay the board back onto the transmitter's heat sink. The remaining cables to the Main Board are left connected.
10. Using the picture below, locate C324 on the bottom side of the Main Board and remove it. Replace it with a 0.039 uF (39000 pF capacitor). A 0603-size part fits on the original pads. A slightly larger 0805-size capacitor can also be used (as shown in the photo) if you first scrape away a bit of the solder mask on the ground end to accommodate the larger part.

11. Locate R392. Verify that it is a 10 k ohms. The value code "103" is printed on top of a 10 k resistor in very small print. (Placing an ohmmeter across R392 in the circuit will read about 6.5 k to 7.5 k, depending on the polarity of the ohmmeter leads, if it is a 10 k.) My DX-70 came from the factory with a 10k, however the schematic in the service manual shows it as being a 4.7k. If the value is other than a 10k, replace it with a 10 k 0603-size part.
12. Reassemble the unit, reversing Steps 1 through 9 above. Remember to push the locking tabs back in after reconnecting the ribbon cable (step 8). Also be sure to carefully align the connectors when reinstalling the Connector Unit (step 5) the lower chassis rail (step 4).
