# Kenwood TS-830

*Survival Guide*

Kenwood TS-830 Survival Guide, ed. [Olaf Rettkowski](#), DL9AI, ver.1.2, 03 Dec 2002

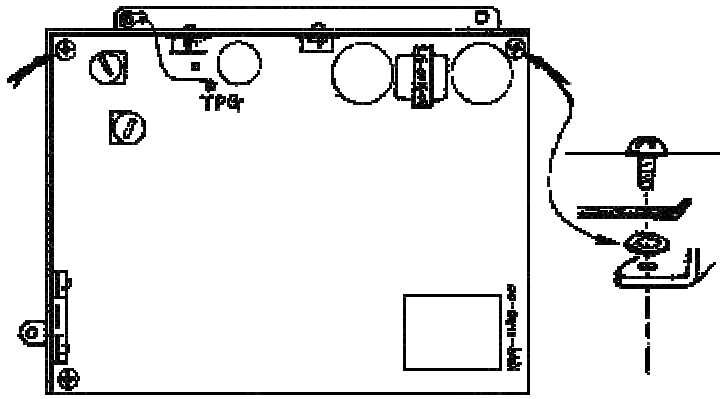
Some users may report an intermittent shift in the display and operating frequency. This may typically be a 1 to 4 KHz random shift. Cause will be a loose grounding screw on the AF/AVR unit heat sink.

1. Remove the top cover (8 screws) and unplug the speaker.
2. Remove the bottom cover (8 screws).
3. Remove 5 screws holding the AF/AVR unit and swing the board over. Leads do not have to be unplugged.
4. Add two tooth-lock washer as shown.
5. Replace the circuit board and heat sink to the chassis, adding the solder lug as shown.
6. Solder a jumper between the TPG wrap post and the added solder lug.
7. Replace the top and bottom covers.

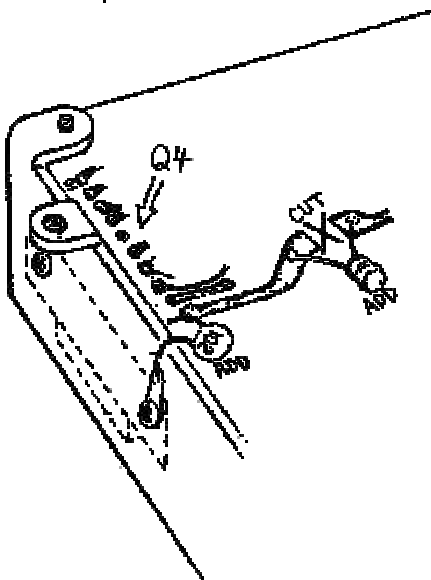
Transmitter "talkback", either with or without a linear amplifier, may be eliminated by adding a filter at the receiver audio power amplifier.

On the AF unit X49-1140-00 at Q4, cut the 12 V DC B+ line between R47 and C28, and add a 1  $\mu$ H choke (L40-1092-02) in-line. Add a 0.01  $\mu$ F cap (C52-1710-36) from the IC pin 1 to ground, as shown using a 3 mm lug (E23-0015-04) under the IC mounting screw on the heat Sink.
