To all Yaesu VR500 Owners

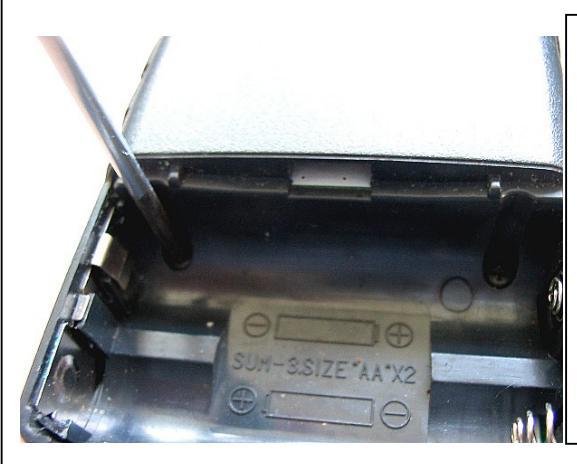
Take off the battery cover, remove the batteries and locate and remove the two screws as shown, either side in the upper part of the battery enclosure. These are self tappers! This is most important to remember on re-assembly.

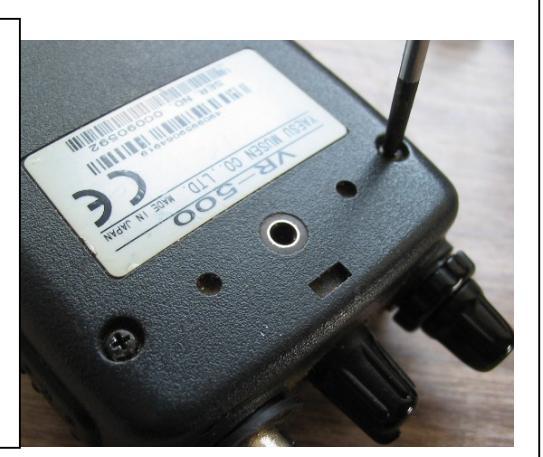
Next remove the two screws from the upper part of the back cover. These are machine screws and not the self tapping type fitted lower down.

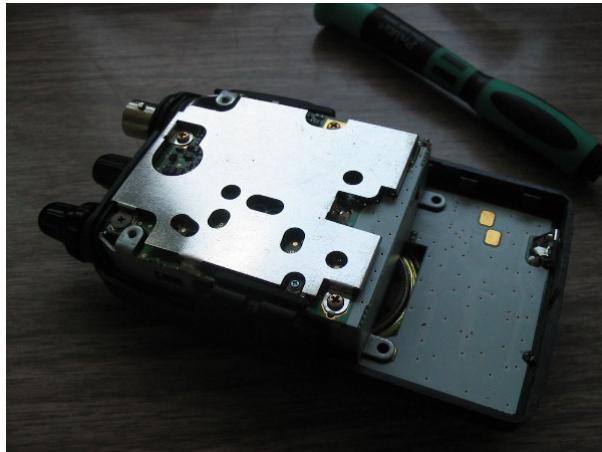
The rear cover should now lift off, with a little persuasion, to reveal the internals as shown.

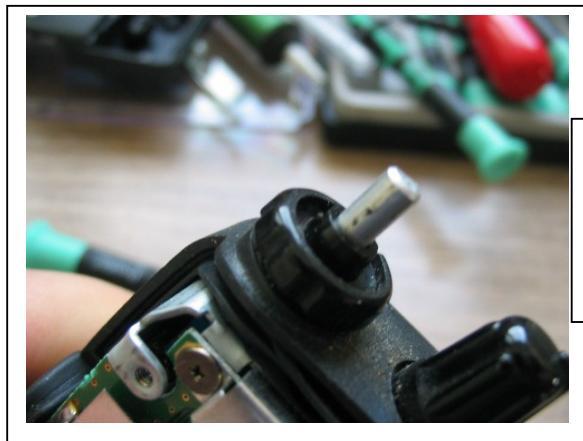
Next you have to remove the knobs, first pull off the small channel/freq change knob.

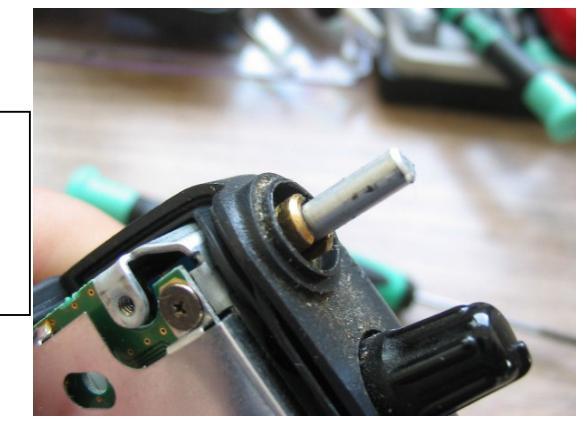
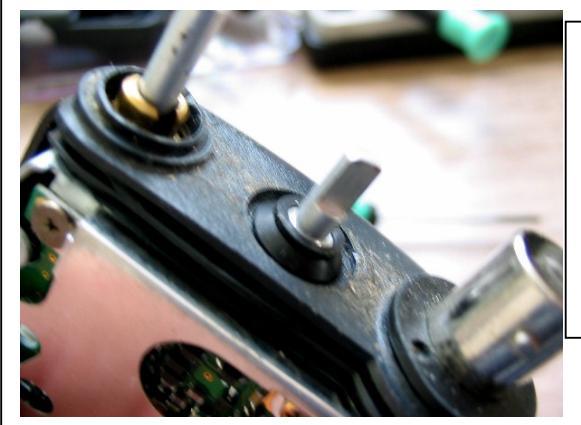
Then the lower one that does the squelch.

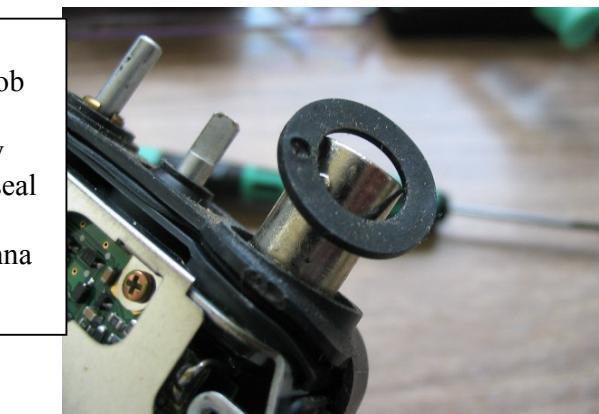
Next the Volume knob pulls off followed by the rubber seal around the BNC/Antenna connector.

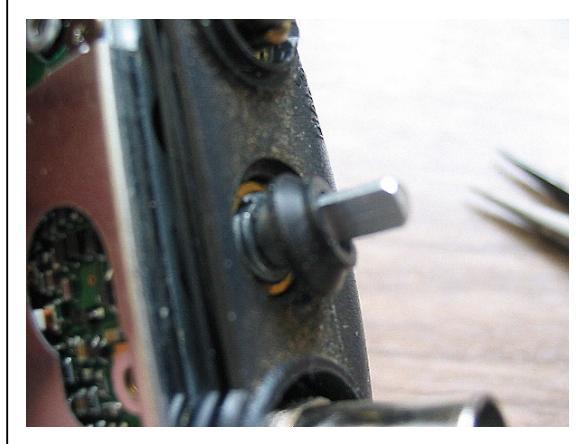
Next is the removal of the small seal that is under the now removed volume knob.

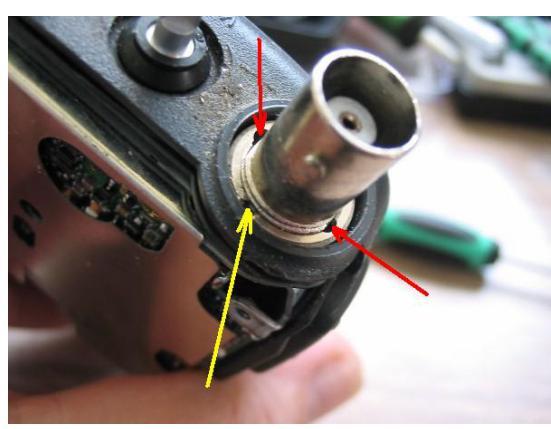
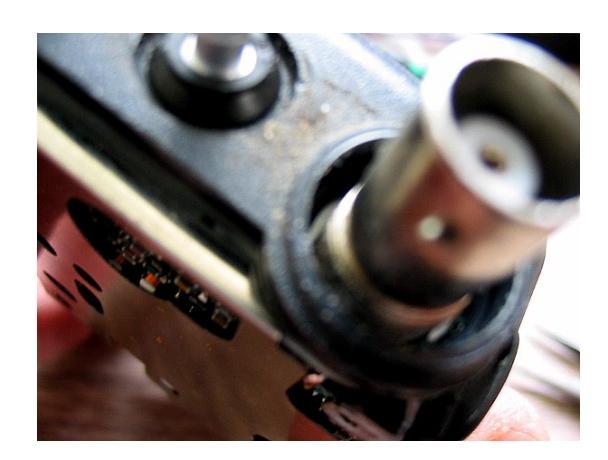
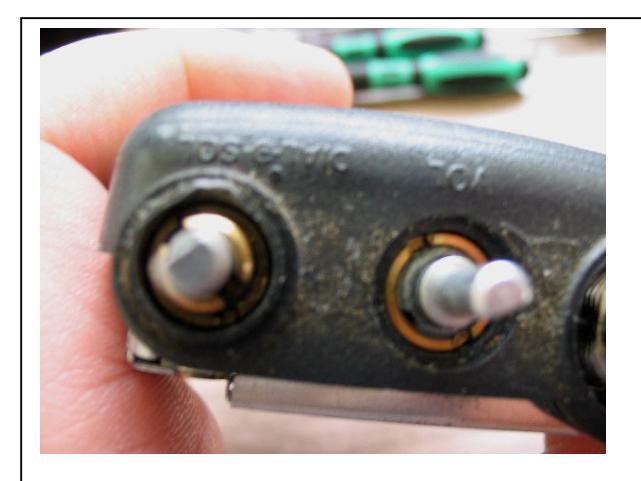
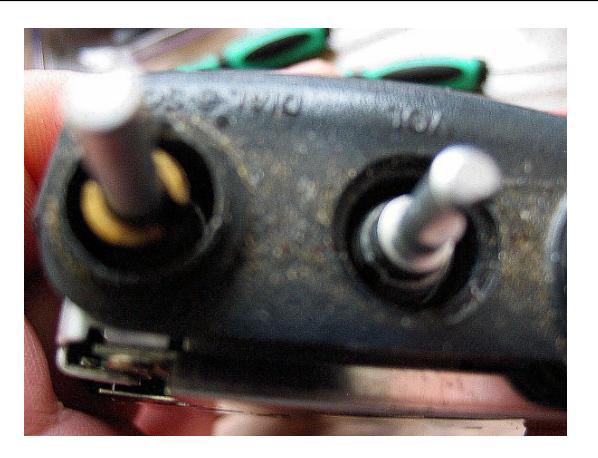
Now the first of the tricky operations starts. This is the removal of three circular fixing nuts that are located under the three items just visited. I did not have the special spanner required for these but the photo on the left gives a clue as to how I removed the fixings. A pair of thin long nosed pliers were used to engage in the slots of the rings and to enable the rings to be unscrewed, normal anticlockwise rotation to remove. The YELLOW arrow is one of the unscrewing slots, the RED arrows show the cutaways that allow the ring to slip over the BNC socket.

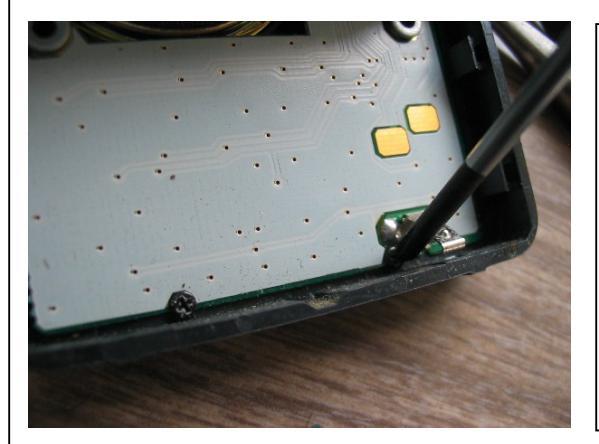
Next remove the two small screws holding the keypad board at the bottom of the case.

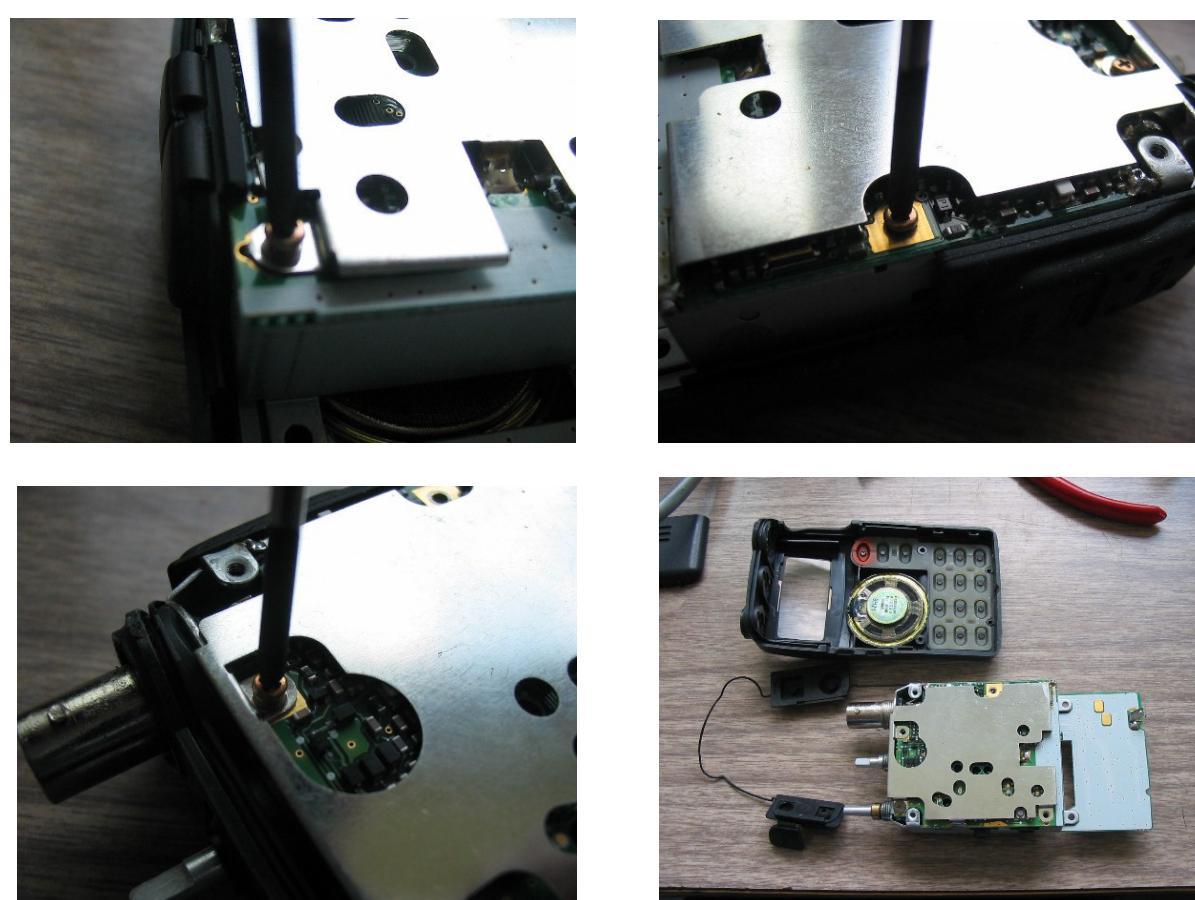
With these fittings removed, it should now be possible to remove the remaining half of the plastic case including the loudspeaker. As this was my first attempt I accidentally removed some board fixing screws that did not need removal until the next step. However, it did not make any real difference and I will show these being removed prior to case removal just for keeping continuity in the photographs. If you have already removed the case then removing these next three screws is your next step.

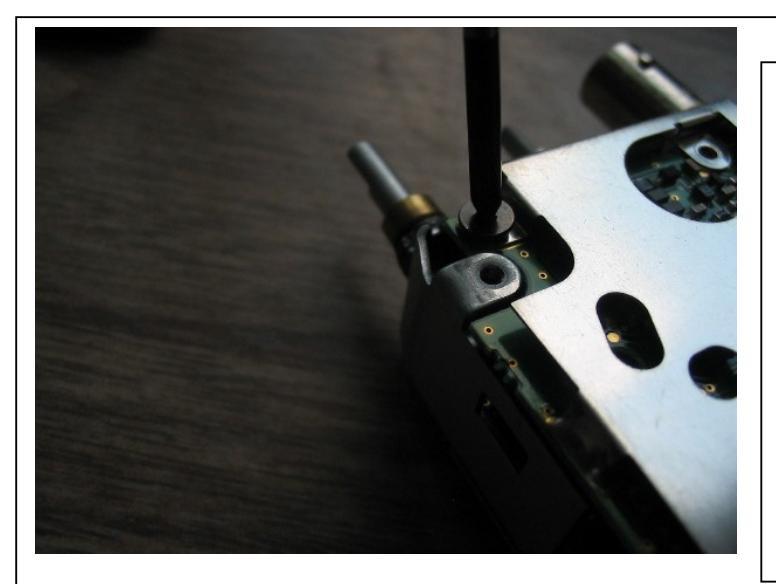
The last photo is where you should be now, put the case and rubber seal/switch covers safely to one side.

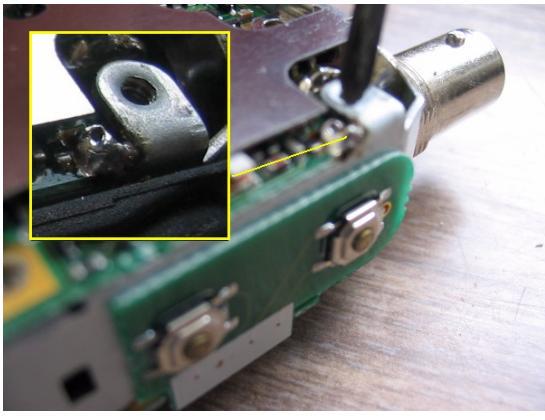
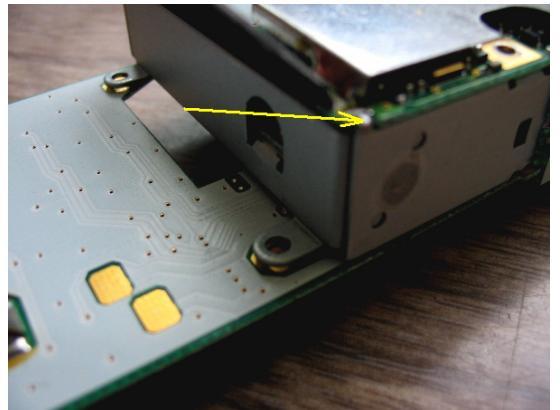
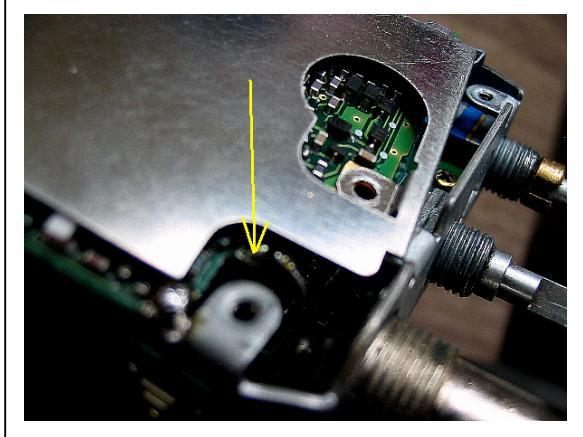
Remove the funny flat head screw located close to the offending channel switch. Now you will need the soldering iron to unsolder at three locations. These are at two chassis earth points and the antenna input from the BNC socket center terminal. The latter is unsoldered at the board and NOT at the BNC socket.

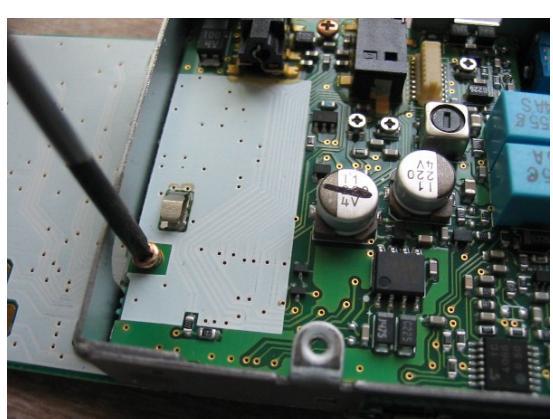
This upper board can now be lifted up and away to reveal a second board beneath. Now we have to remove another three screws for this board, which once done, will allow the board to be removed by sliding to the right (as viewed on the photos) and slightly upwards. It is easier to do than to describe!

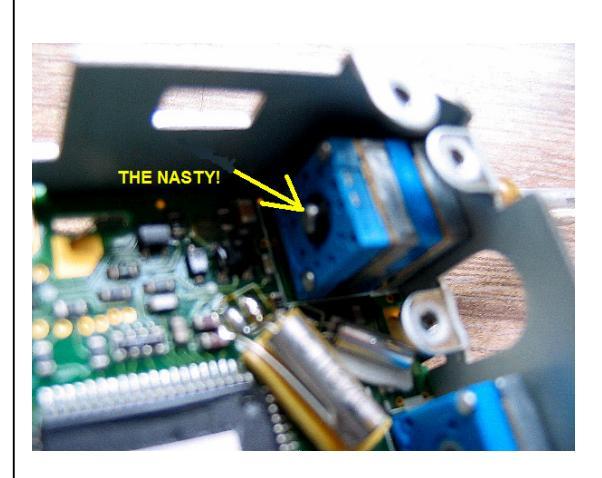
Pull board up to disengage the white rectangular connector then slide right and upwards to clear. frame.

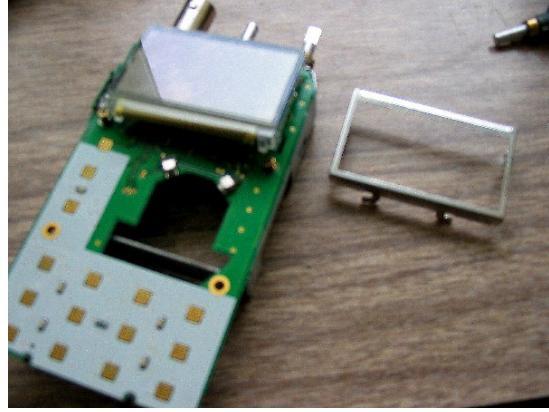
Escutcheon removed.

Left is another view of THE NASTY! Still a bit to do yet before we can extract it and the going gets really tough from now on. We have to remove the metal frame after first removing the LCD metal escutcheon. When this is removed, the LCD is hanging perilously by three small wires on one side. The LCD must therefore be treated with utmost care to ensure minimum displacement until we get it all back together again. The escutcheon is removed by carefully bending back its securing tabs.

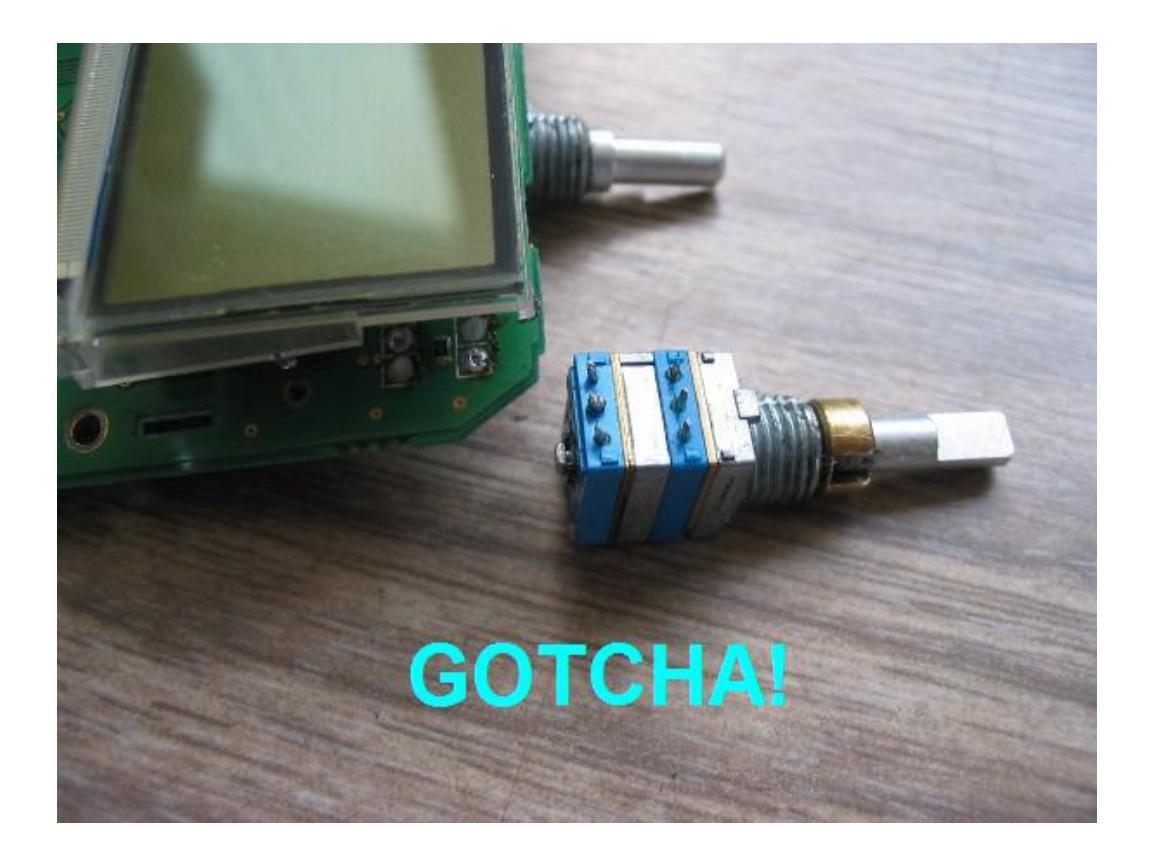
How did I get the little XXX out? Well I laid the whole soldering iron bit across all six solder pads of the switch and melted them all at once. At the same time I was applying pressure to make the switch let go of the board but also making sure the iron did not destroy the LCD!

I wish I had had an assistant to help me but somehow I managed to do it. I also figured I could clean the board up afterwards and when the switch had been removed, I found it easier to solder suck from the other side of the board, that is the switch body side.

I cannot stress too much the need for minimum movement of the LCD. Just raise it gently to give sufficient access for the soldering iron bit and NO MORE!

It may be helpful to slightly trim the tags of the new switch before fitting. The reason for this is that the new switch has slightly longer tags than the old one removed. If you do not trim the tags, they will stop the LCD setting down in its correct position. If you leave them long you will find it difficult to trim the tags without lifting the LCD display and this should be avoided as much as possible.
